Manhole Inspection Summary

Manhole # S15CC1013MH

Insp Date: **3/22/07 1:53 PM**

Location Address: **3736 COTTAGE AVE**

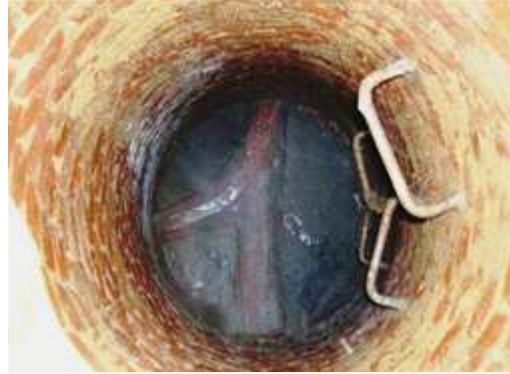
Top View

Corroded steps. Evidence of surcharge - Bench debris.

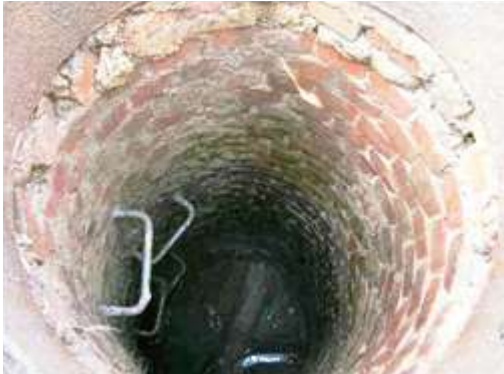
Defect

Frame leaks. Adjustment deterioration, loose brick and infiltration Corbel and Barrel root intrusion and infiltration - other

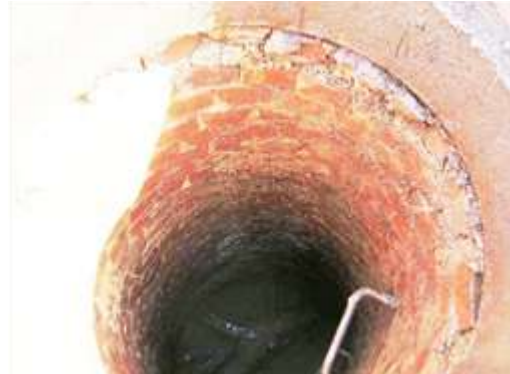
Defect

Frame leaks. Adjustment deterioration, loose brick and infiltration Corbel and Barrel root intrusion and infiltration.

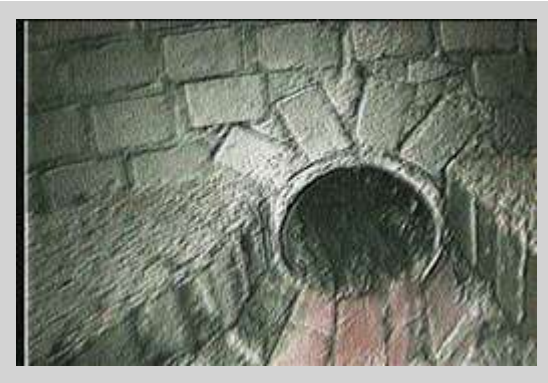
8 in. Circular Gravity Sewer Pipe Out @ 12 O'Clock

Barrel deterioration and infiltration. Channel deterioration.

Deposits: ☐ None ☐ Mud ☐ Sludge ☐ Debris ☒ Grease

Infiltration: **Evidence** Pipe Seal Cond: **Unknown**

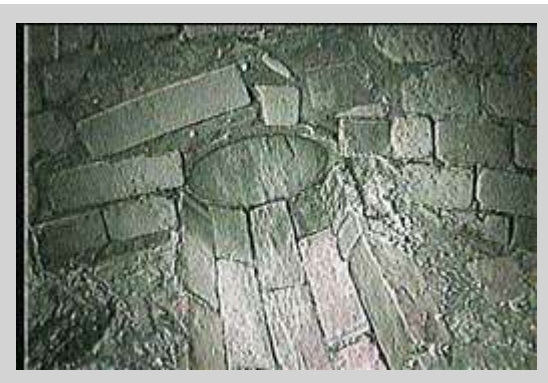
8 in. Circular Gravity Sewer Pipe In @ 6 O'Clock

Barrel deterioration and infiltration. Channel deterioration.

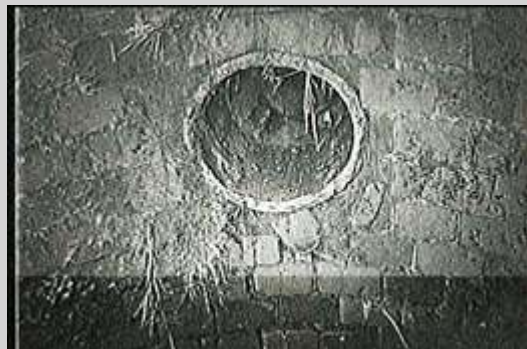
Pipe In @ 9 O'Clock

Infiltration: **Evidence**

Pipe Seal Cond: **Roots**

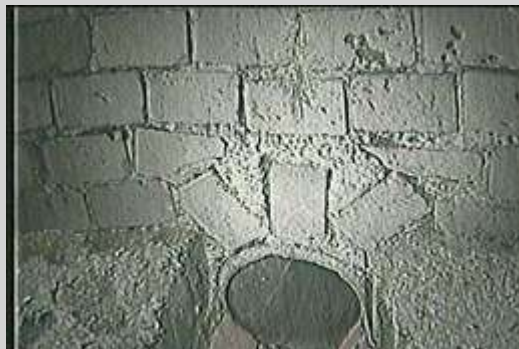
Drop In @ 9 O'Clock

Barrel root intrusion.
